Restoration of Sarria Church

Astrid Vella

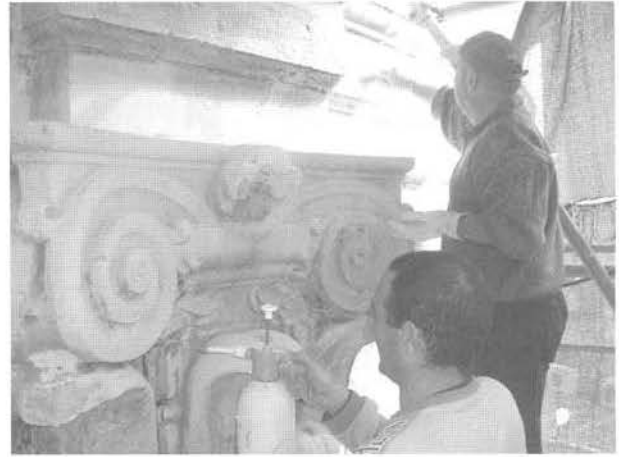
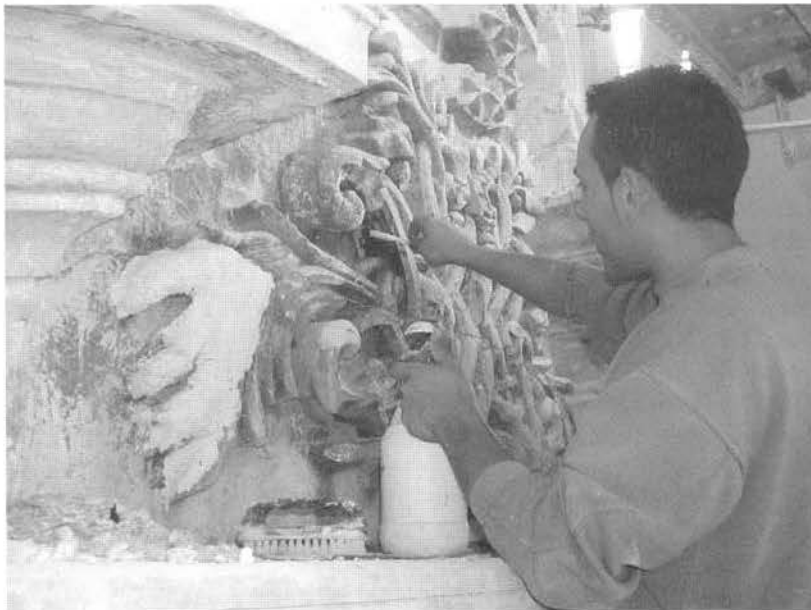
Here and above: Restoration work at Sarria church

powdery and liable to attack from airborne pollutants. The delamination it displays, with stone surfaces 'cracking off' in thick flakes, is also very acute, its full extent and severity revealed by the use of a thermal imaging camera which highlights areas of delamination in different colours since they differ in temperature from the main body of the stonework.

Because of this, fine cracks were filled by injecting special lime mortars to consolidate the delaminating stonework as soon as initial cleaning was carried out. As well as brushing and washing of the stone surface this also entailed the removal of vegetation, old cables and rusted nails and hooks. Decaying areas of special interest such as sculpture are being treated with consolidant liquids which, when absorbed by the stone, solidify within it, strengthening it without reducing its porosity. Careful prising away of the most recent layers of paint is all carried out by hand mainly using surgeons' scalpels; slowly but surely the door surrounds and mouldings which had been submerged under many layers of paint are now beginning to emerge.

Worse still is the layer of cement rendering (plastering) which had been applied mainly to the lower level of the church. The bane of every restorer's life, cement render poisons the stone on which it is laid, as salts seep from the cement into the stone causing deterioration by salt crystallisation. Furthermore, the cement coating prevents the damp from evaporating out of the stone, forcing it upwards instead, carrying the salt deterioration higher. Cracks in old cement also allow the ingress of acidic rainwater which causes further deterioration of the stone face behind the cement layer. Although it is no easy task, hand removal of old cement is therefore a priority at Sarria church.

Then begins the process of replacing stonework which is irremediably decayed; in order to retain as much as possible of the original stone, stones are only being replaced as a last resort in the case of decayed blocks which pose a danger of structural weakness. The church face is then cleaned by the application of poultices in the form of pulped paper impregnated with a weak ammonia solution and laid on each and every stone block. By the time it is lifted off after 15 minutes, the solution will have softened up the centuries of dirt
